METALS RESEARCH

RESEARCH REPORT
CFT RR 81-15

FLAW GROWTH OF 7075, 7475, 7050 AND
7049 ALUMINUM ALLOY PLATE IN STRESS
CORROSION ENVIRONMENTS (CONTRACT
NAS8-30890): 4-YEAR MARINE
ATMOSPHERE RESULTS

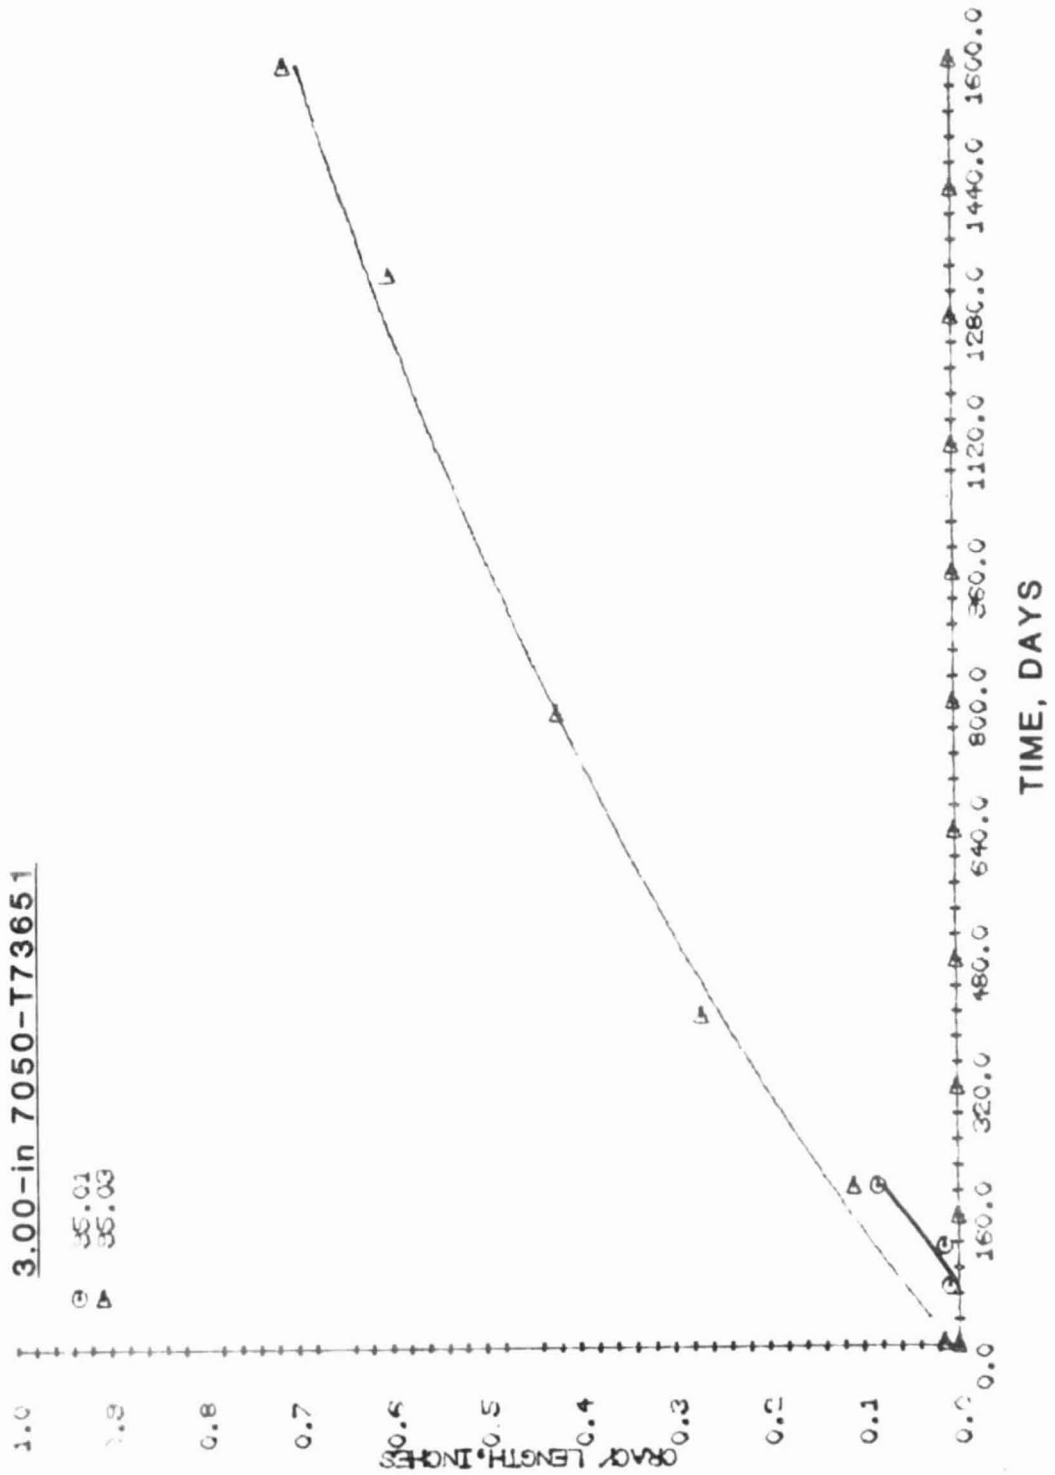
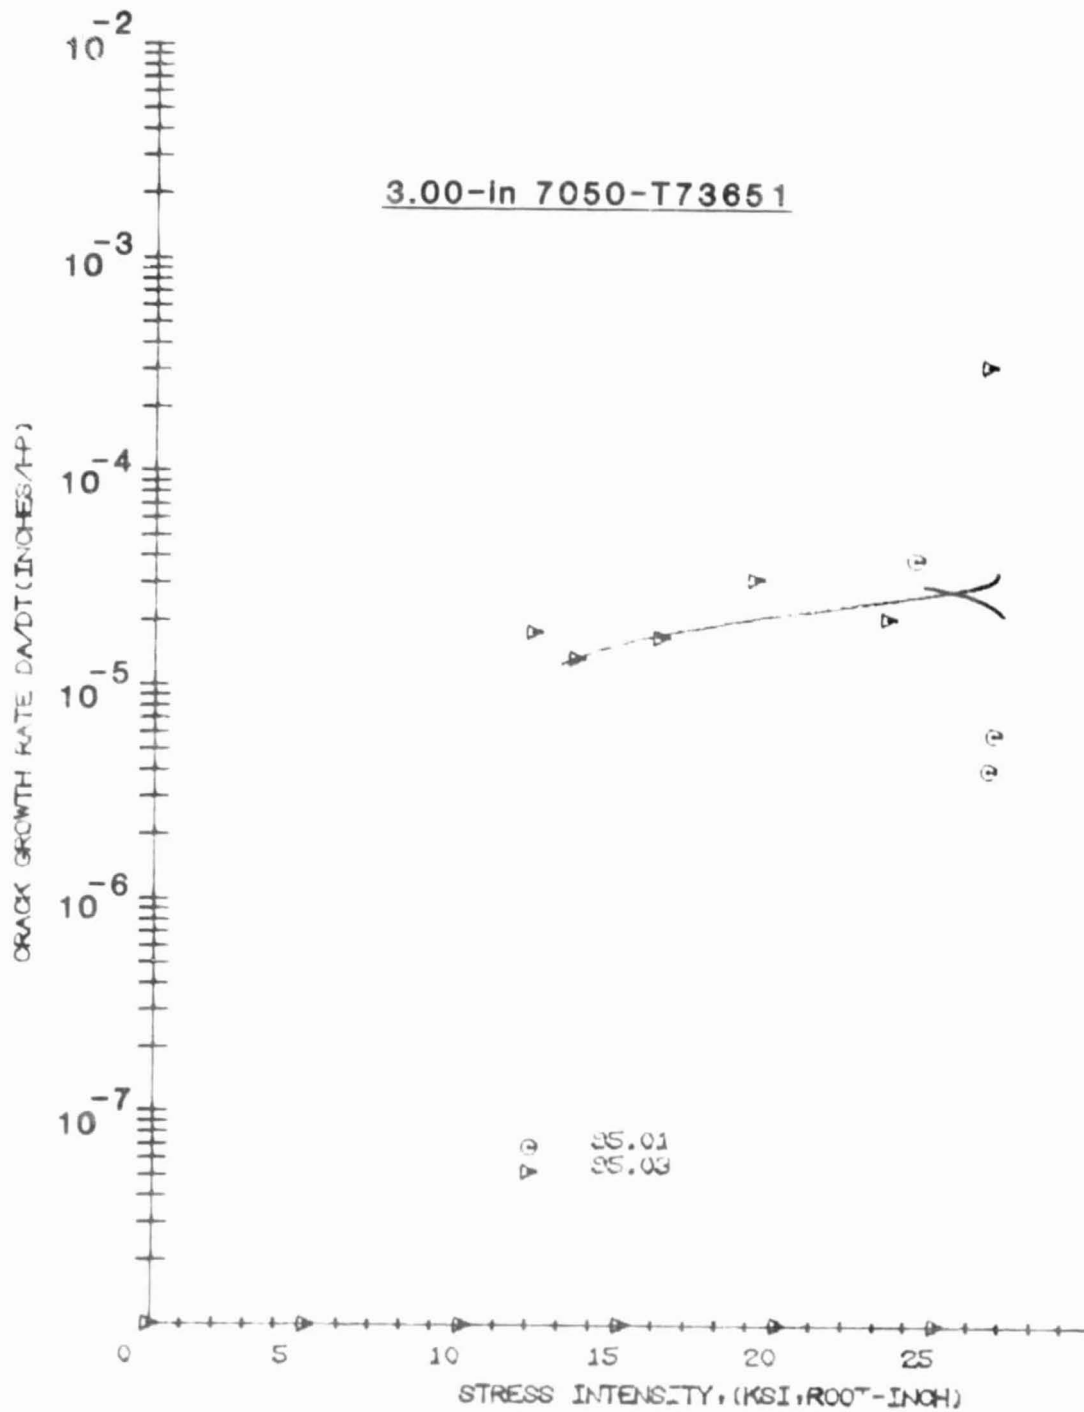
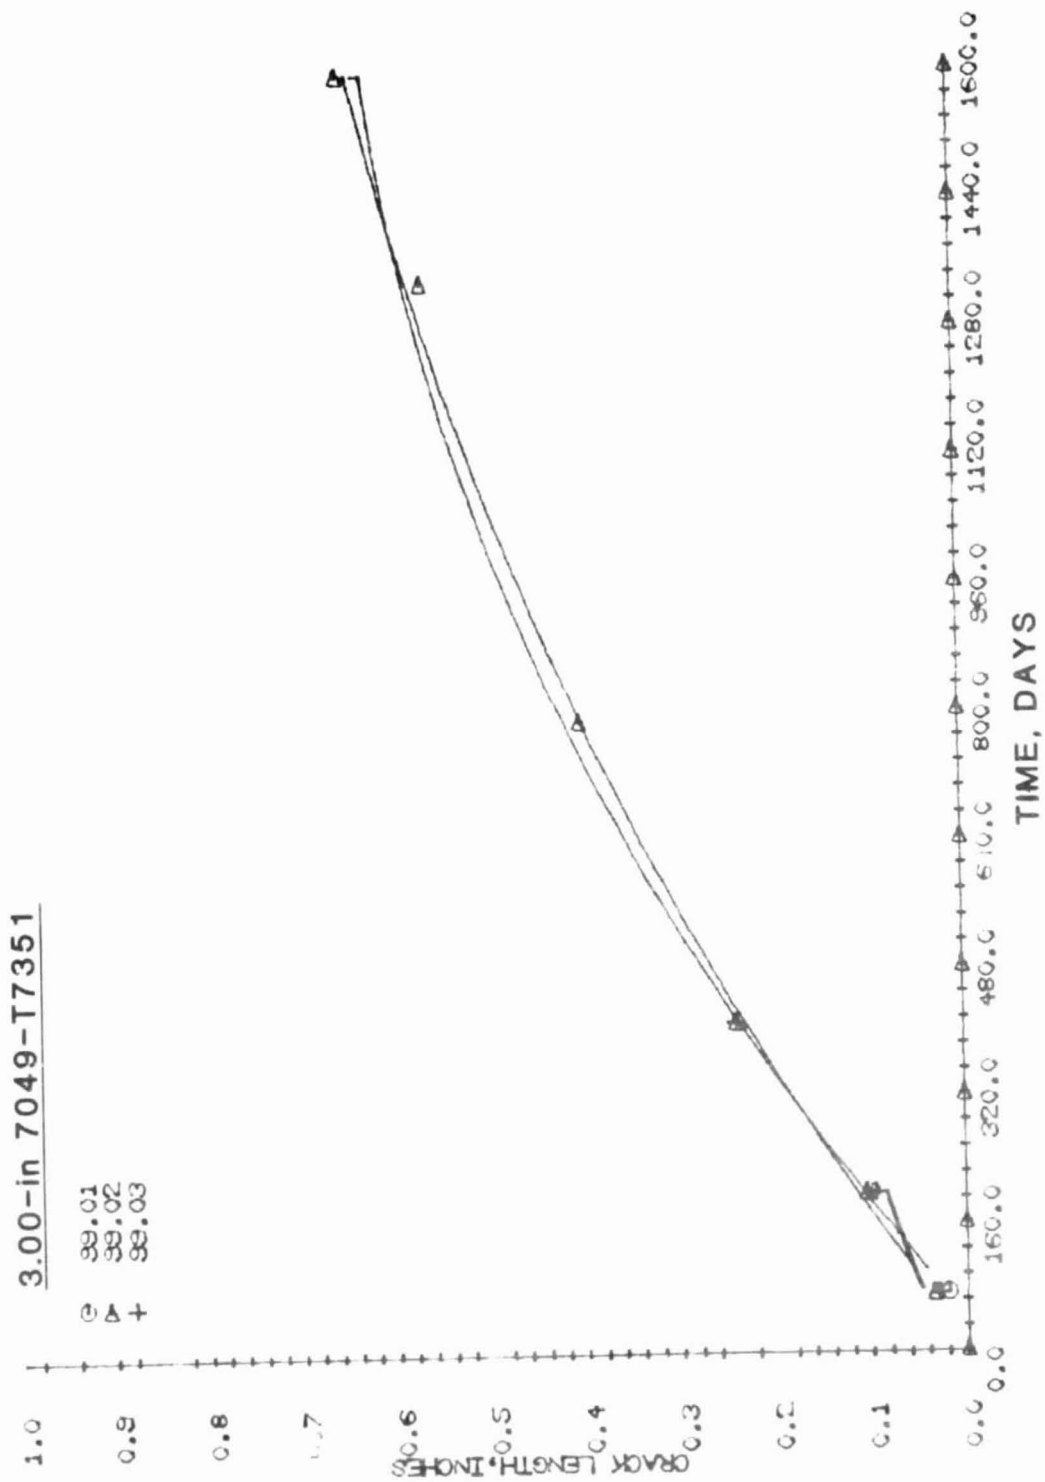
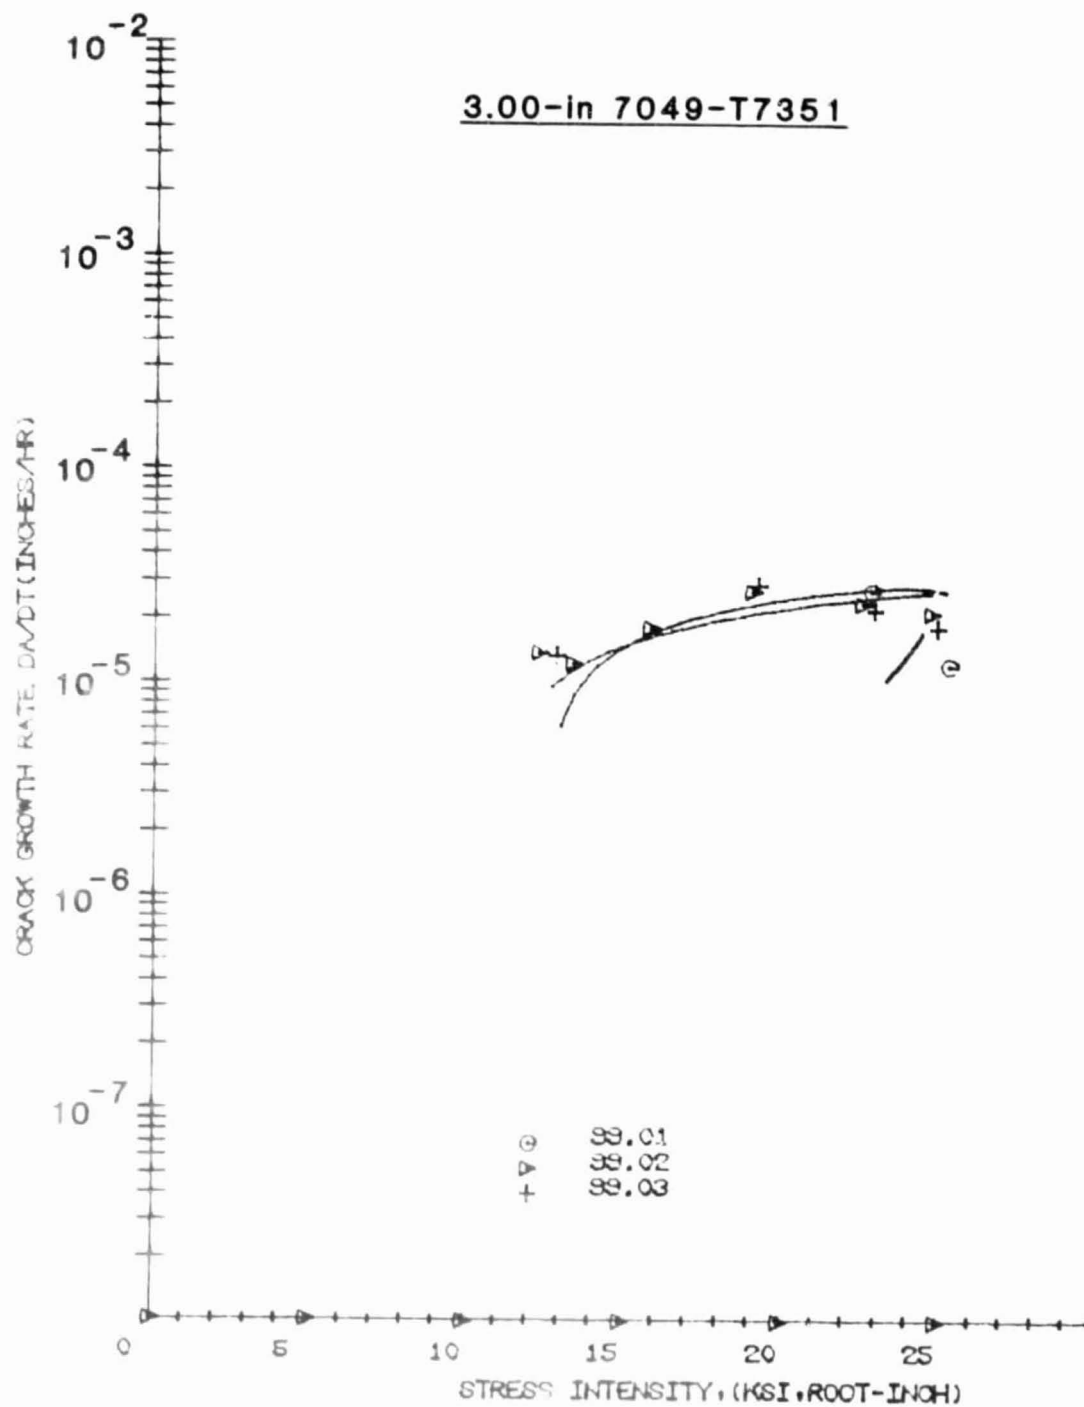
3.00-in 7050-T73651

Curves were fitted to crack length time data using a transformation and polynomial regression. Stress intensities and crack growth rates (da/dt) determined from these curves were then used to construct the V-K plots. Given sufficient data and minimal scatter in the crack length data, this method provides good results.

Certain factors can bias the curves, however. For example, the first specimen in each set of triplicates was terminated after six months exposure. This test period did not provide enough data to determine the SC behavior of the resistant -T7351 temper materials. The curves for the specimens exposed only six months are therefore frequently inconsistent with those exposed for longer times. Greater apparent scatter, possibly from crack initiation effects, was a contributing factor.

Some bias is shown in the crack length measurements taken at 44 months. All of these measurements tended to be low. This may have been a seasonal effect or the result of bias on the part of the inspector. The effects of the bias varied, depending on the overall performance of the individual specimen.
